Test Report

No. 1530-001-15 dated 05.02.2015

Improvement Factor of Pipe Clamps in the Test Stand

Heavy Duty Clamp
BIS HD1501 with noise insulating inserts made of
EPDM-rubber on measuring tubes ½", 1", 2", 4" and 6"

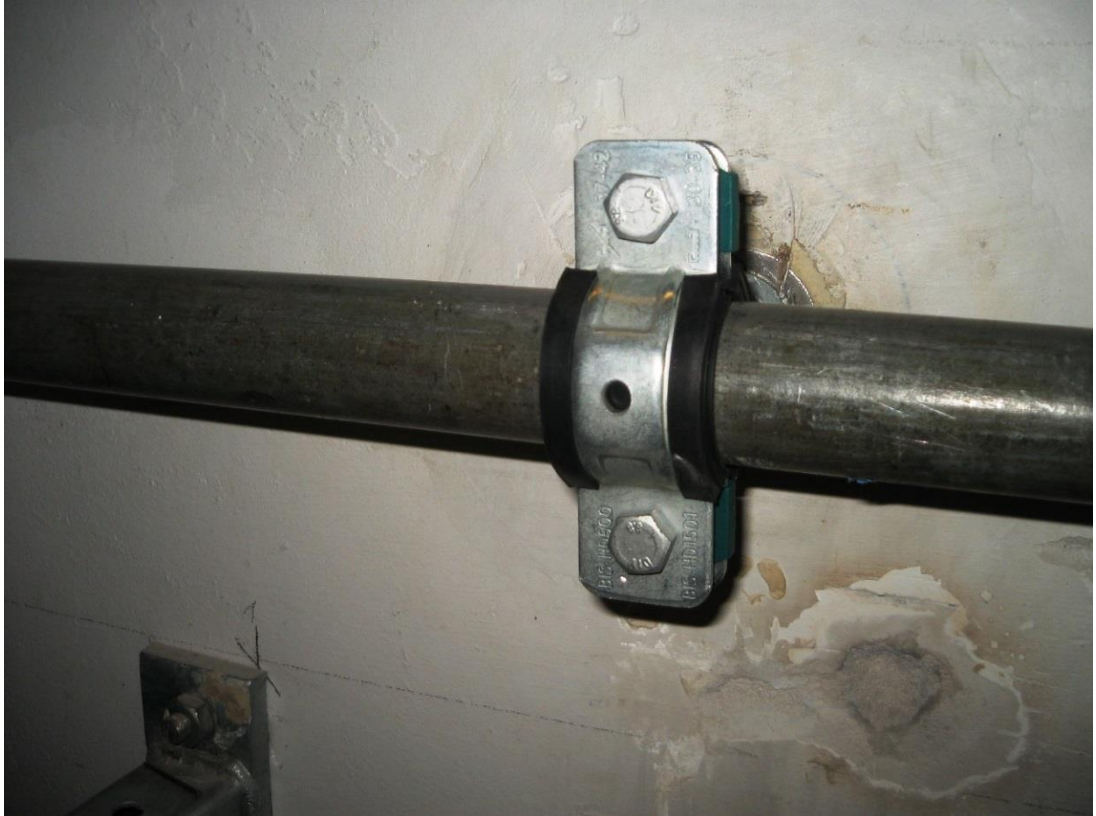
Fig. 1: Meas. 2: Heavy duty clamp BIS HD1501, 1" (30 - 35mm), connection M8/10, EPDM-rubber (30 x 4,00 mm)

| Measurement 2: | Heavy duty clamp BIS HD1501, 1" (30 - 35 mm), connection M8/10, two-screw-clamp with EPDM-rubber (30 x 4,00 mm) (Enclosure 3) |

Meas. 2: Heavy duty clamp BIS HD1501, 1" (30 - 35 mm) **VM $L_{IN} = 15$ dB(A)**

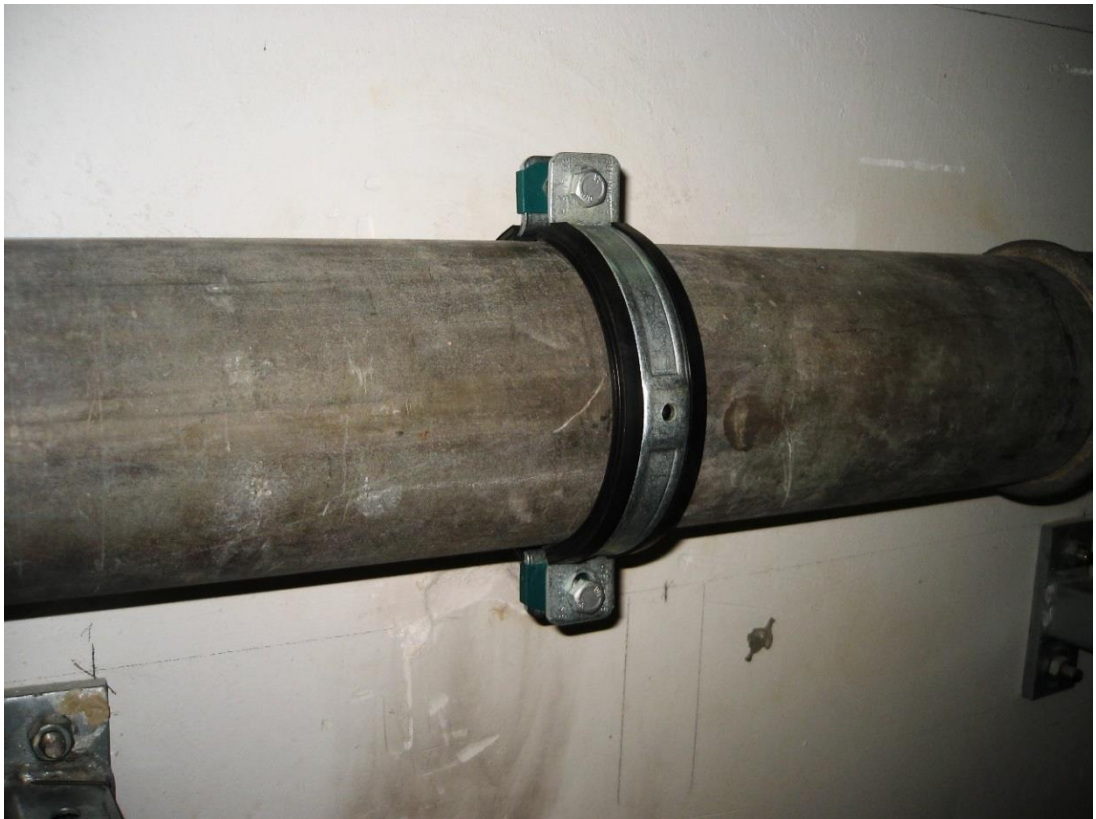
Fig. 2: Meas. 4: Heavy duty clamp BIS HD1501, 4" (108 - 116mm), connection M10/12, EPDM-rubber (30 x 4,00 mm)

| Measurement 4: | Heavy duty clamp BIS HD1501, 4" (108 - 116 mm), connection M10/12, two-screw-clamp with EPDM-rubber (30 x 4,00 mm) (Enclosure 5) |

Meas. 4: Heavy duty clamp BIS HD1501, 4" (108 - 116 mm) **VM $L_{IN} = 17$ dB(A)**
